# CONDITION REPORT – EU3785

Victorian Block, Jebb Avenue, Brixton SW2  
5XQ

Date of survey: Thursday 17<sup>th</sup> December 2020

Prepared For: Guy Crotty  
Jebb Avenue Management Committee

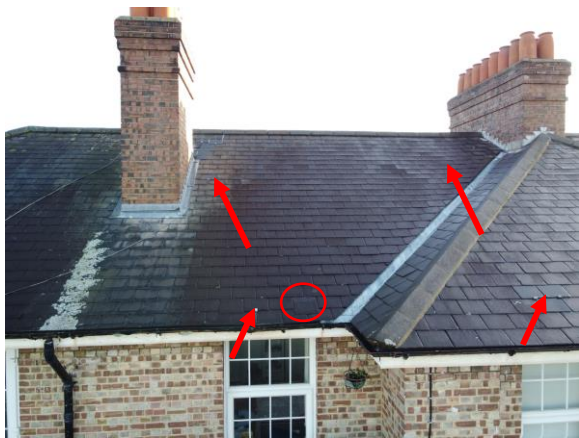
Slate identified as Penhryn ‘County’ Grade Natural Slate  
Evidence of slate slippage and previous attempts at repairs to localised slates.

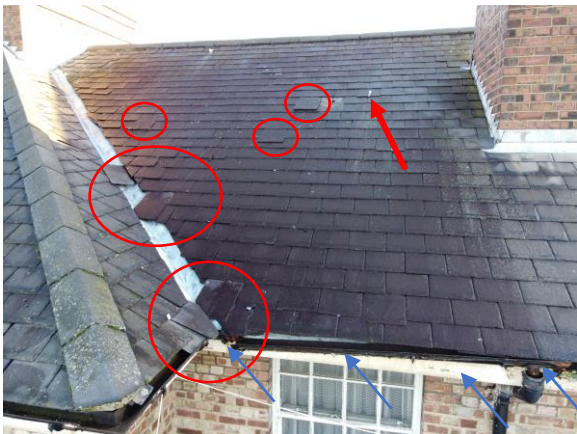
Evidence of loosening of slates due to wind damage, and possible vortex on leeward side of hip and leading to failure of fixings.  
All Guttering to be replaced.

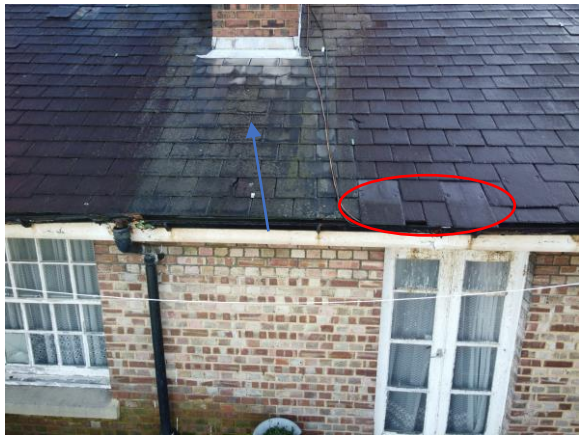
Insufficient or no fixings used to install, no evidence of nails being used through slates.  
Evidence of High water Absorbency below the chimney stack.  
Which would indicate slates are approaching the end of their useful life.

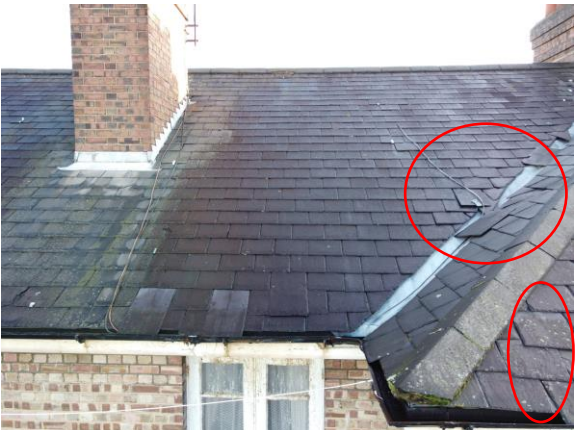
Evidence of loosening of slates due to wind damage, and possible vortex on leeward side of hip and leading to failure of fixings.

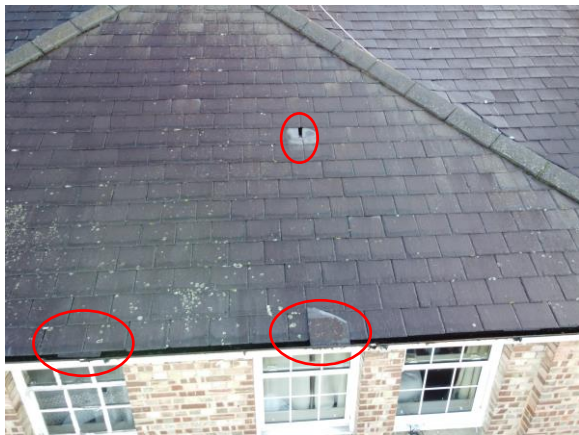
Insufficient or no fixings used to install roof covering.  
Under Eaves course of slates appears to have dislodged in places manifested by slate in gutter as shown.

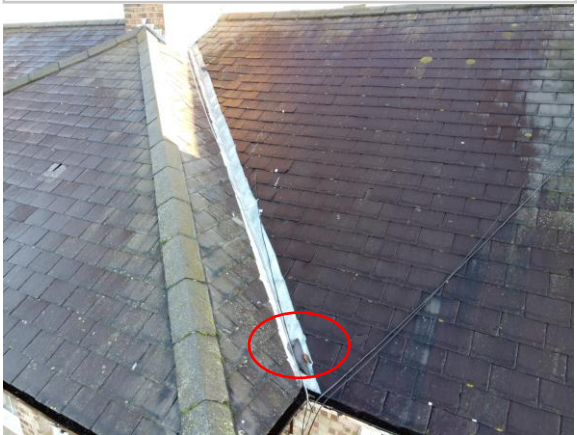
Further evidence of Slate slippage in the valley, as before described.

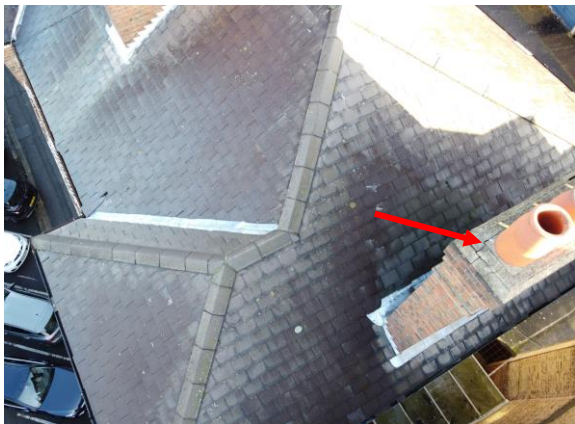
Pointing failing around chimney stacks possibly leading to water ingress.  
All concrete ridges to be replaced to bring up to necessary BS5534:2018 using mechanical fixings .

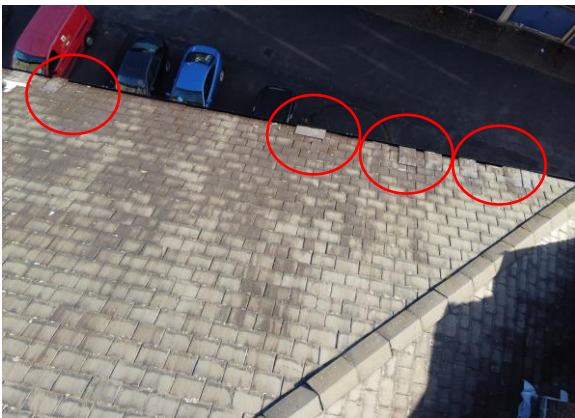
Evidence of Slate slippage on eaves course presenting a Health and Safety concern for the pedestrians at street level.

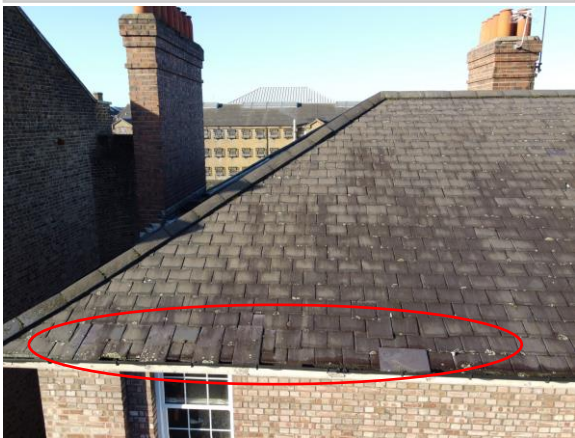
Evidence of Slate slippage on *eaves course*.  
Ageing of slate leading to higher moisture content indicated by darker areas & potentially leading to the softening of Slate.

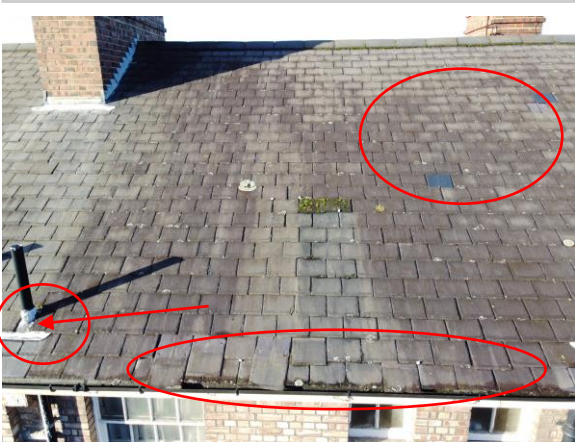
Faulty slate to Soil Vent Pipe and missing balloon.  
Very strong evidence to support ageing of slates and tile slippage and nail sickness.  
Localised remedial repairs not in keeping with fabric of roof.

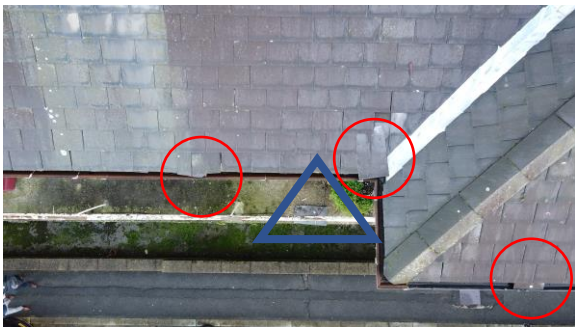
Health and safety high alert as slate has dislodged and fallen over the gutters and into the terrace below.  
highlighted by triangle on fig.  
Slate slippage causing potential harm to building occupants and pedestrians

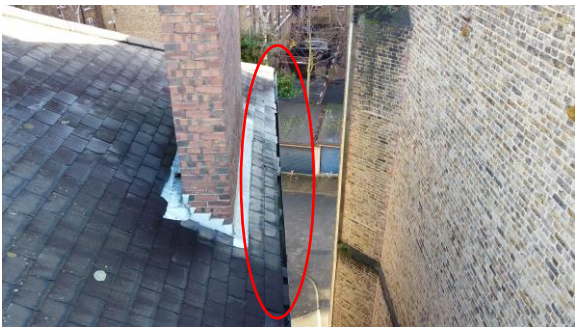
High water absorbency in slate manifested in darkening of material.  
Numerous slates counted in gutter on this elevation (circa 9).  
Evidence of significant failure and obvious Health and Safety concerns.

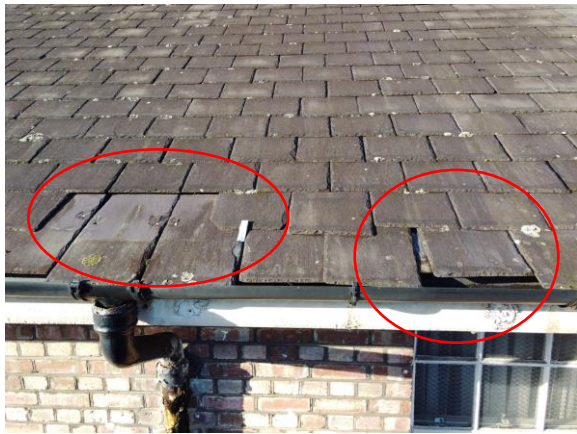
Evidence of Slate slippage on eaves course. As before described

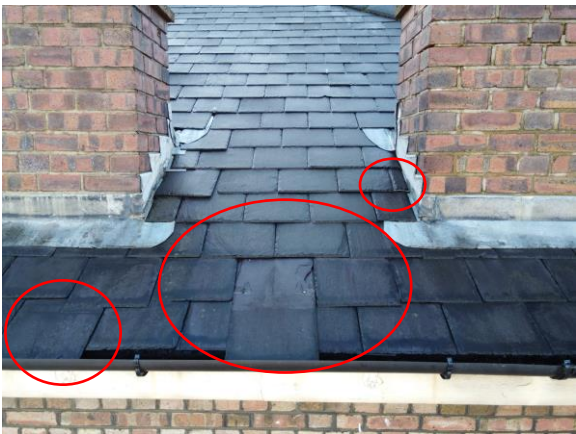
Slate not installed in compliance with BS5535:2018/BS8000 part 6. Recommend Abutment slates minimum 150mm so as not to compromise side-lap. Normally, all abutments should be taken from slate and half and we haven't seen any slate and a halves in use.

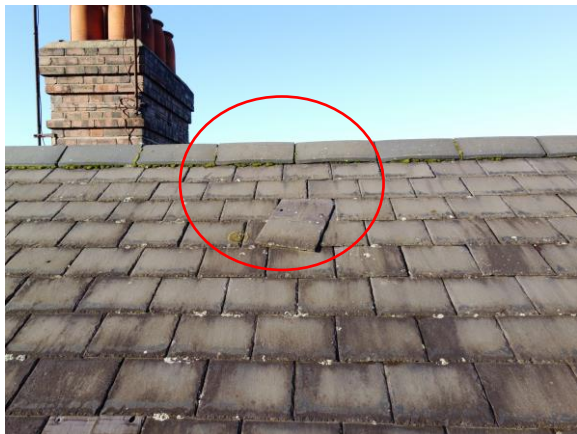
Integrity of ridge line starting to harbour moisture shown as green moss growth directly beneath ridge. Dark hue on circumference of slates is indicative of a higher level of moisture content/absorption. Further slate slippage.

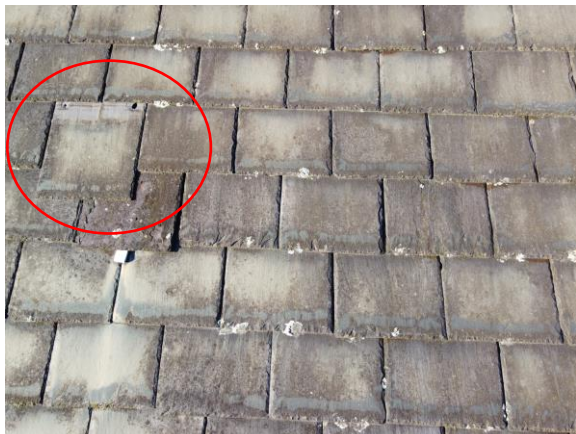
High levels of calcification evident from whitening on surface, geological symptoms of a softening slate. Further slate slippage

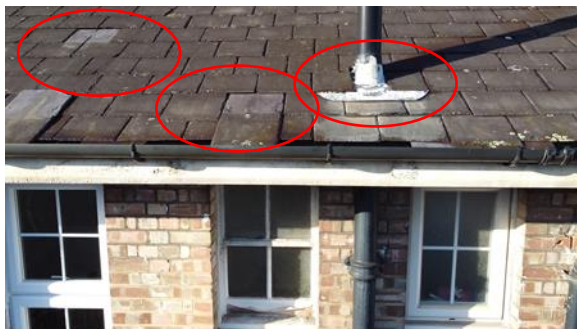
Failing lead slate to soil vent pipe and apply balloon Very strong evidence to support ageing of slates and tile slippage and nail sickness.

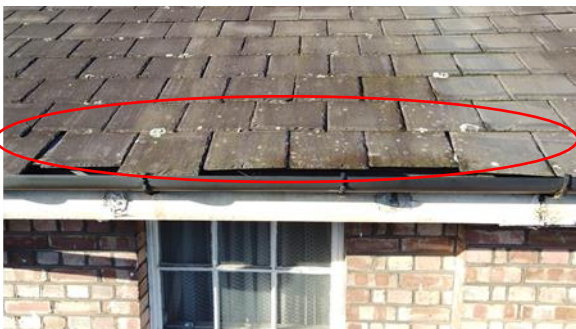
Noticeable slant on the eaves course perhaps caused by water ingress to the internal roof structure and swelling of roof structures. Evidence of top edge of fascia board rotting hence drop in eaves course.

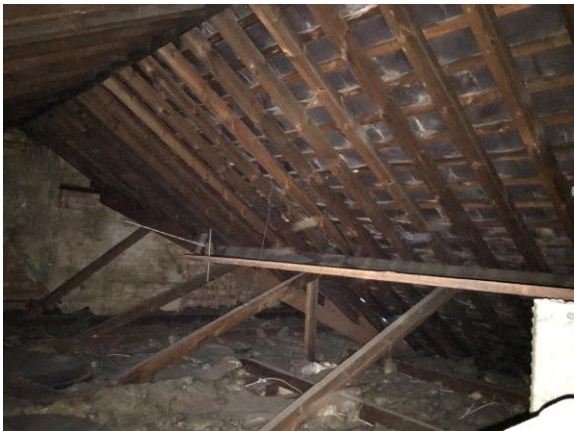
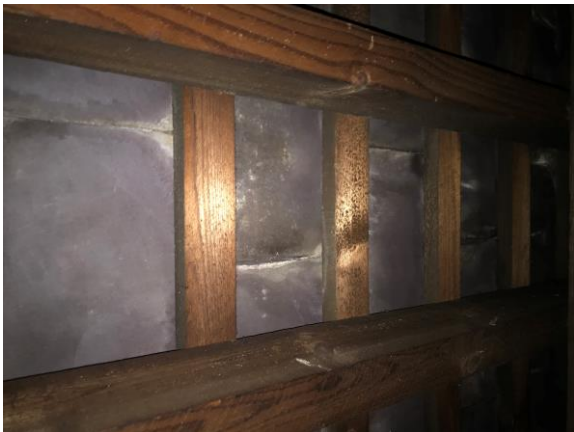
Internal loft space –Un-felted, evidence of water ingress can be seen to the underside of slate perp joints, showing angle of creep and calcification of slates.  
Evidence of water staining can be seen on purlin.

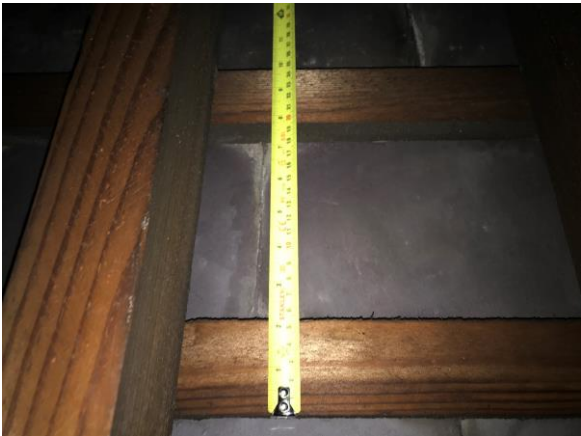
Image confirming existing batten gauge, 200mm,  
Slate lap, 100mm.

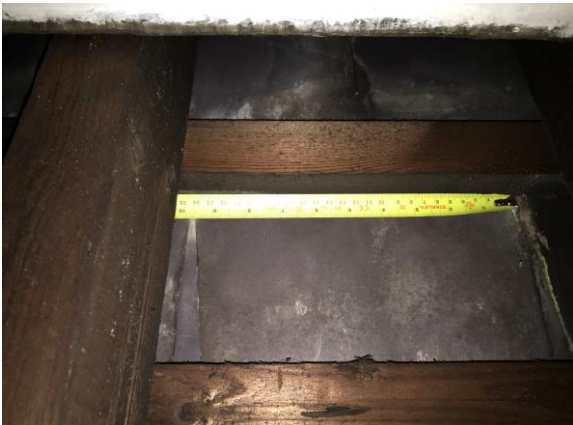
Confirmation of slate width.
