Re: Survey for Jebb Avenue

Client: Jebb Avenue Management Company  
Project: Jebb Avenue  
Project Ref:: 38232

## ICOPAL SITE SURVEY

## 1. PROJECT OVERVIEW

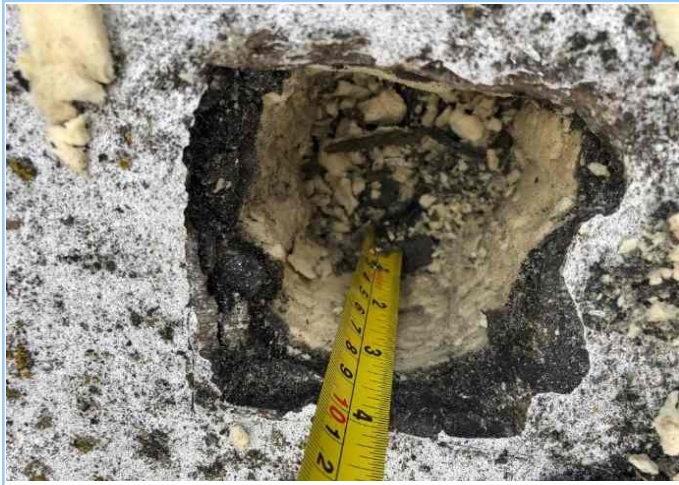
##### Core Sample 1

Location: Central

Build Up: Concrete deck. Bituminous VCL. 80mm insulation. Asphalt. Solar reflective paint.

Core Result: Dry.

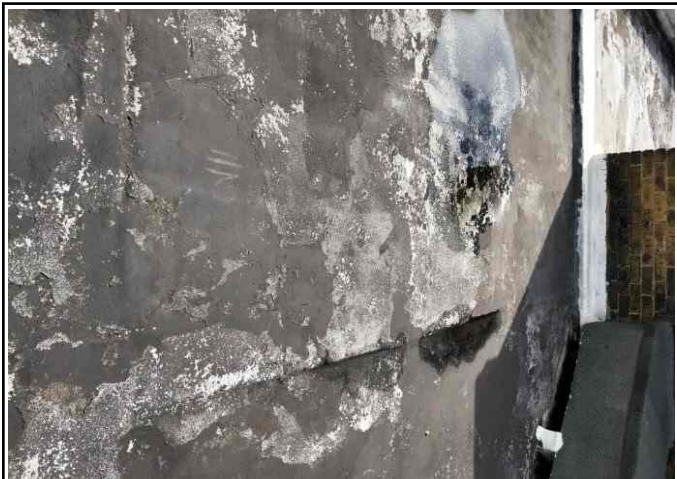
It is evident that the roof is now in a generally poor condition, with natural ageing playing a significant role in its deterioration.

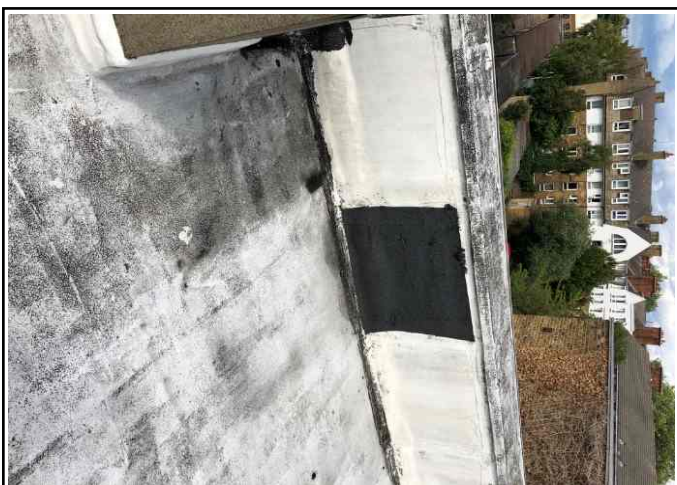
The existing waterproofing has been extensively repaired, but it is apparent that the repair has not resolved the problems of the roof. As the waterproofing has passed its useful life, the rate of water ingress can only be expected to increase.

In our opinion, the existing waterproofing will only provide short term protection, however we consider that the existing roof waterproofing system is of satisfactory condition to receive a new Icopal high performance overlay.

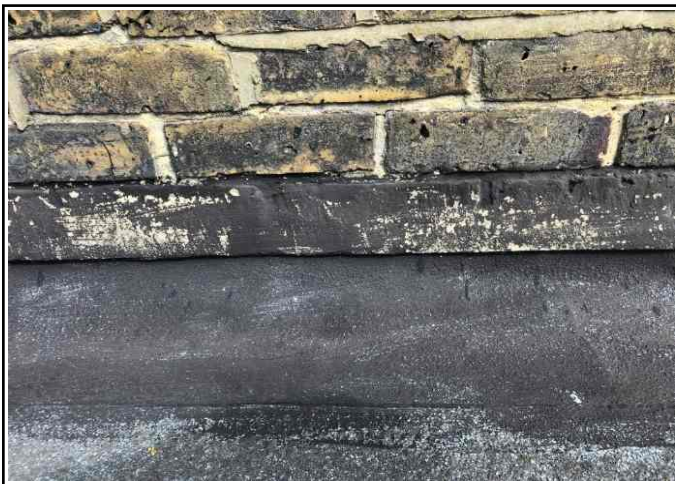
Pointing to the chase has deteriorated, creating a potential for water ingress.

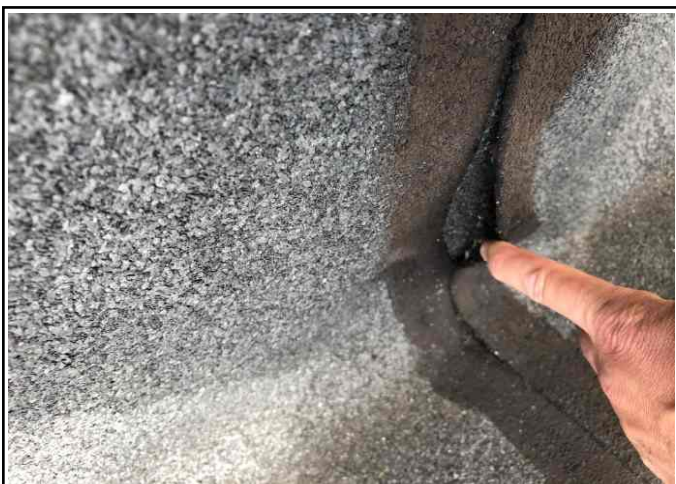
Cracking is evident within the waterproofing membranes at details across the roof suggesting movement has occurred between the roof and the building structure.

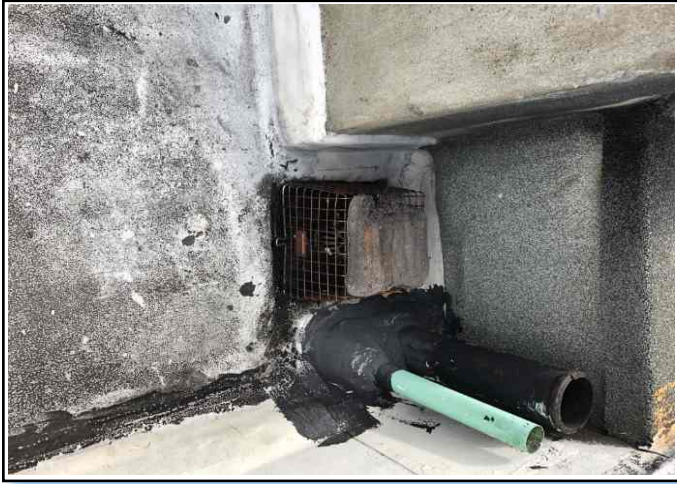
The roof is draining to roof outlets.

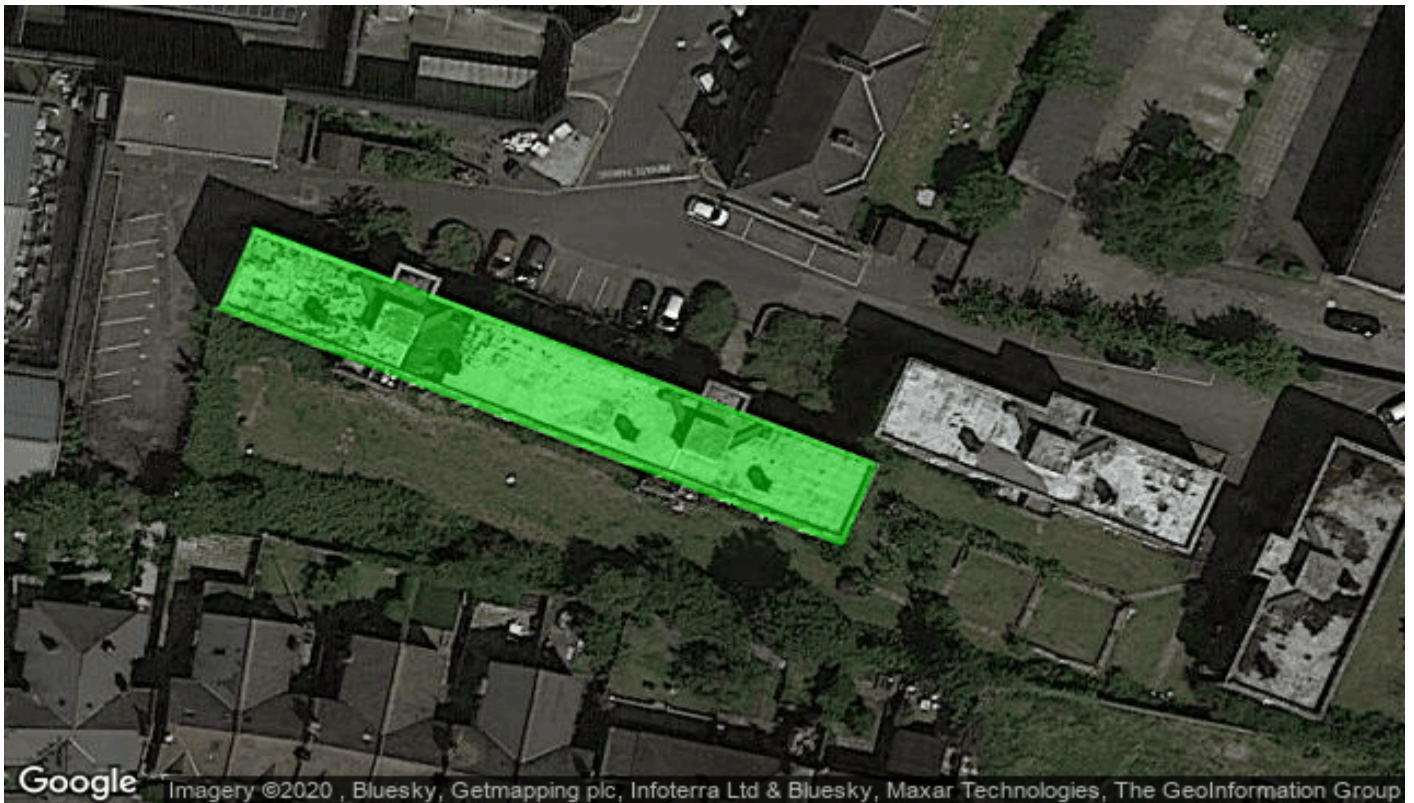
### Plan View - Jebb Avenue

Visual impression of the areas where it is not Safe2Torch ■ No Naked Flames ■ Safe2Torch
