Re: Survey for Jebb Avenue

Client: Jebb Avenue Management Company  
Project: Jebb Avenue  
Project Ref:: 38232

## ICOPAL SITE SURVEY

## 1. PROJECT OVERVIEW

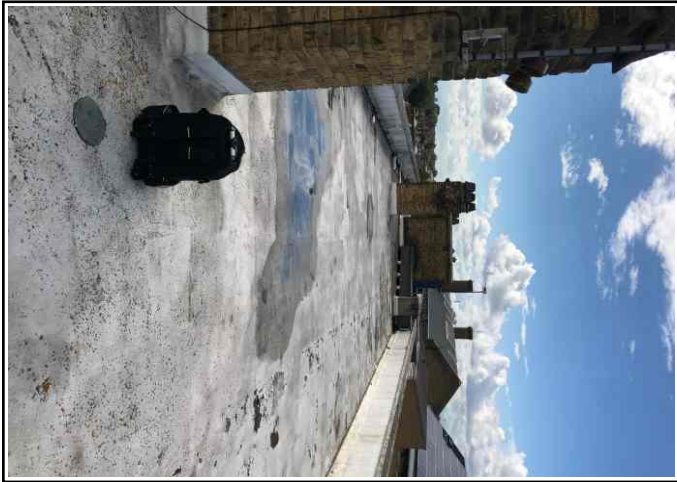
Core samples are only an indication of the roof build up in the area inspected. Icopal take no responsibility for changes in the roof build up outside the immediate area of inspection. It is the responsibility of the roofing contractor to satisfy himself of the existing roof build before tendering.

It is evident that the roof is now in a generally poor condition, with natural ageing playing a significant role in its deterioration.

The existing waterproofing has been extensively repaired, but it is apparent that the repair has not resolved the problems of the roof. As the waterproofing has passed its useful life, the rate of water ingress can only be expected to increase.

In our opinion, the existing waterproofing will only provide short term protection, however we consider that the existing roof waterproofing system is of satisfactory condition to receive a new Icopal high performance overlay.
